Reducing rail noise with acoustically optimised crossings

The noise generated by trains passing over turnouts can pose problems for railways, particularly in residential areas. Laboratory trials have shown the potential benefits of high-damping polyurethane composites, and a field test is currently underway on the ÖBB network in Austria.

**Martin Quirchmair,
Thomas Titze, Uwe
Ossberger and Harald Loy***

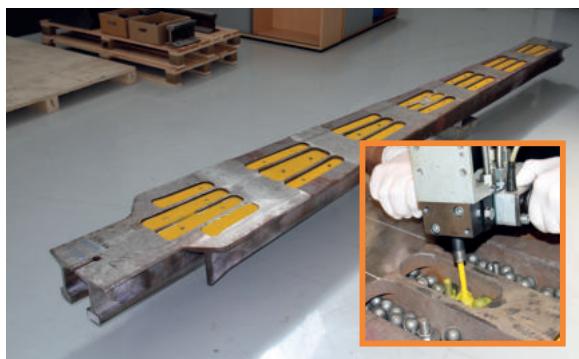
Top: Fig 1. Composite material for the damped turnout crossings used in the field test at Pfaffstätten.

The mineral filling was replaced by a metal filling, which could be introduced without any additional handling (Fig 1).

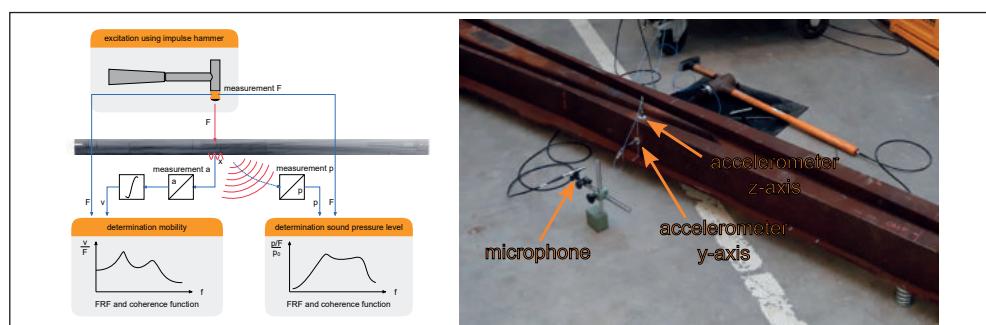
Above: Fig 2. Measurement concept and measurement set-up for the experimental modal analysis on the turnout crossing.

To ensure the best possible comparison between the laboratory and field results, we needed a measurement set-up that could be used in approximately the same form in both situations. We therefore adopted an experimental modal analysis process (Fig 2).

We decided to measure the acoustic radiation from the cast crossing as a result of an excitation using an impulse hammer. To ensure that we could measure a wide range of frequencies, we actually used two different hammers. A large hammer with a soft tip provided excitation of the lower frequency spectrum up to approximately 100 Hz, while a small hammer with a hard tip was used for excitation of the higher frequency spectrum.

Excitation took place approximately 350 mm behind the theoretical crossing point, at approximately the height of the wheel transition point. The impact on the crossing was made at an angle of 45°, in order to introduce vertical and horizontal force components simultaneously.

To evaluate the impact, we recorded the mobility represented by the vibration velocity normalised to the excitation force, as well as the sound pressure normalised to the excitation force. The vibration velocity was determined by integrating the signals of the accelerometer attached in both the horizontal (y-axis) and vertical (z-axis) directions. The acoustic radiation was measured by using a microphone at a distance of 400 mm from the crossing, level with the top of the rail.

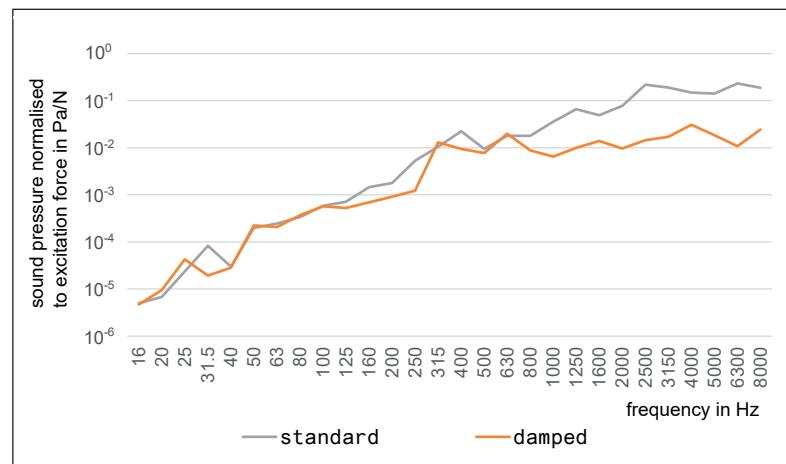
Fig 3. Excitation-normalised sound pressure of the prototype crossing when tested under laboratory conditions.

filled with the polyurethane composite material using the mineral filling, and the measurements were repeated. Fig 3 shows the measured sound pressures, normalised to the excitation force, in the third-octave spectrum.

The additional damping starts to take effect from approximately 100 Hz, while the biggest differences can be observed from a frequency of approximately 700 Hz. By forming the sum level across the measured spectrum, this results in a reduction in the excitation-normalised sound pressure of 85% due to the additional damping, under laboratory conditions.

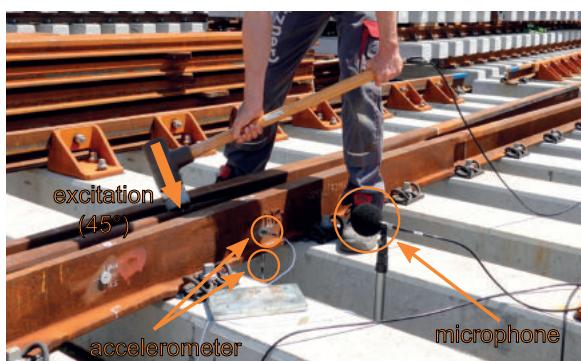
Fig 6. Excitation-normalised sound pressure on turnout crossings W1 (damped) and W2 (standard) as tested in Zeltweg.

As anticipated, Fig 6 shows that the differences in the normalised sound pressures were lower than for the freely oscillating crossing tested in the laboratory, because additional damping had been introduced into the system through the coupling of the crossing to the turnout bearers. The sound measurements were somewhat hindered

by background noise from the plant operations, but a 60% improvement in the excitation-normalised sound level was determined in the sum level, subject to the uncertainty introduced by the ambient conditions.

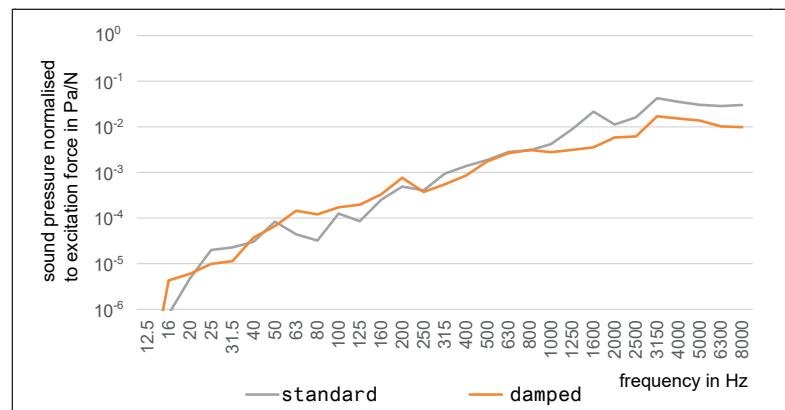
Below: Fig 9. Pass-by noise level of a Railjet trainset passing over the facing turnouts W3 (standard) and W4 (damped) and the trailing turnouts W1 (damped) and W2 (standard). (ref $p_0 = 2 \times 10^{-5}$ Pa)

For the evaluation, we needed to make a distinction between the facing turnouts W3 (standard) and W4 (damped) and the trailing turnouts W1 (damped) and W2 (standard). Between four and six passages by Railjets were evaluated for each turnout.

Fig 9 shows the results as recorded using the single microphone. The damped crossings showed a slight reduction of 1.9 dB in the average sound pressure level for the two facing turnouts, but only 0.2 dB for the trailing turnouts. Due to the insufficient number of passing trains, wide scatter bands within the same vehicle class and minor differences in the averaged spectra, in our evaluation we considered that both situations were approximately the same.

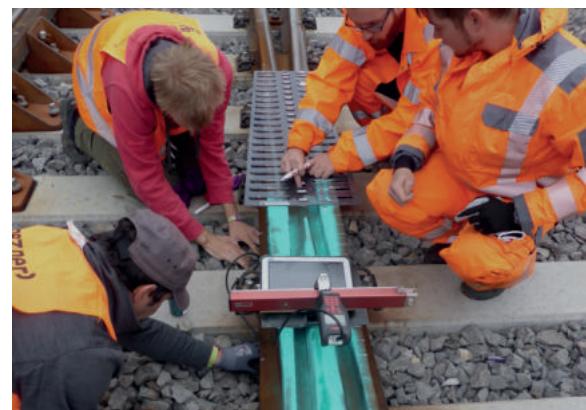
Fig 7. Voestalpine staff checking the turnout crossing geometry at Pfaffstätten prior to the in-track noise measurements being recorded.

in September of that year. The actual turnout geometries were recorded by Voestalpine before the trial (Fig 7) to confirm that all four crossings still had their optimum geometry at the time the measurements were taken.

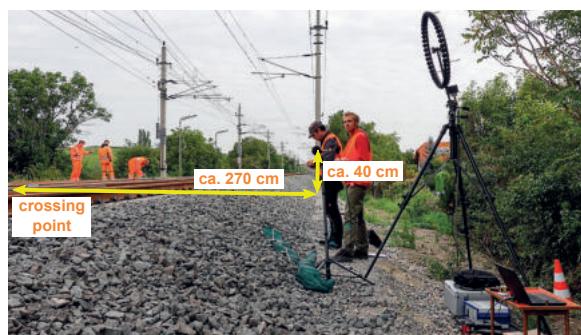
Fig 8. Setting up the measurement equipment to record the noise of passing trains during the field trials at Pfaffstätten.

Acoustic measurement with a single microphone could not be carried out strictly in accordance with DIN EN ISO 3095 due to the local conditions, including the surrounding vegetation and the embankment location, which meant that the recording distances had to be reduced considerably. Fig 8 shows

how the measurement equipment was set up on site.

In addition to the single microphone for sound measurement, we also used an 'acoustic camera' to record the passage of the train. This used a microphone array positioned behind the single microphone.

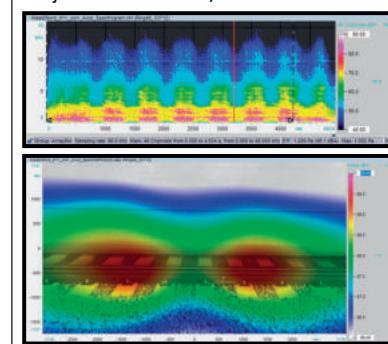
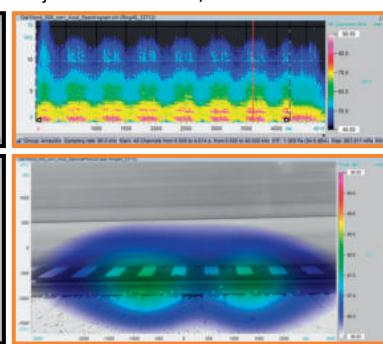
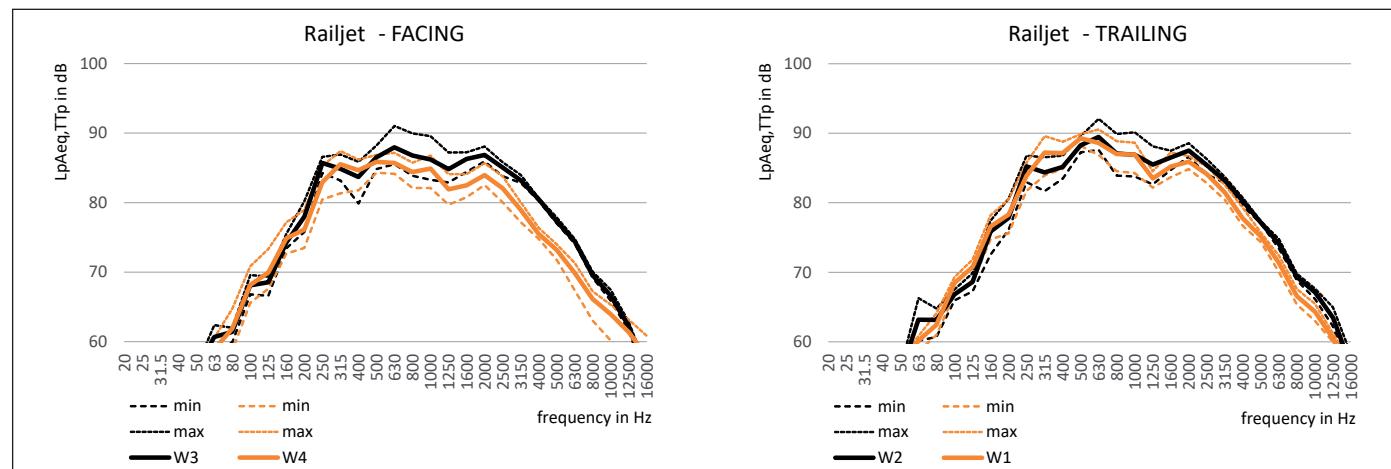
Right: Fig 10. Evaluation of an acoustic camera measurement for a Railjet trainset passing over crossings W2 (standard) and W1 (damped) at 160 km/h.

W2 (standard) - TRAILING

Railjet 13:32 – 160 km/h

W1 (damped) - TRAILING

Railjet 13:17 – 160 km/h

taken with the acoustic camera are only provided to show the potential of the measurement method itself. The process enables sound sources to be localised with the aid of a microphone array, with the results presented as a spectrogram or acoustic image (Fig 10).

In retrospect, the positioning of the microphone array on the outside of the turnout proved not to be ideal. The crossing area on the 'inside' rail was hidden by the passing train, and could not be observed directly. As a result, we intend to change the position of the camera for the next campaign, taking the measurements from the opposite side of the line. Although the crossing will be further from the array, it can be observed directly, and we anticipate that this will provide better localisation of the crossing in the acoustic image.
